Manhole Inspection Summary

Manhole # S19E__004MH

Insp Date: **10/11/07 12:00 AM**

Location Address: **2033 PENROSE-LEXINGTON**

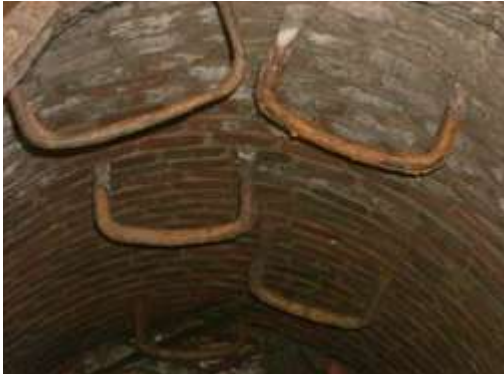
Defect 2

Steps Count: **5** Missing: **0** ☒ **Corroded**

CORRODED STEPS

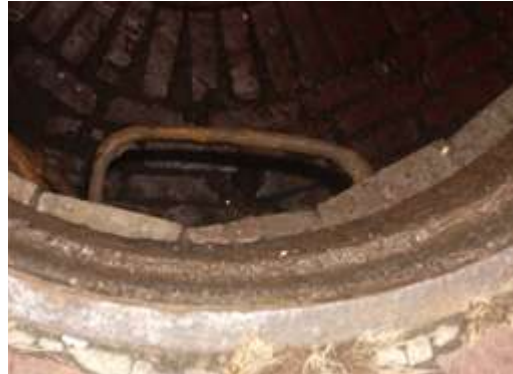
Defect 1

Frame Offset: **1** (in.) Condition: ☒ Sound ☐ Cracked ☐ Leaks

FRAME OFFSET

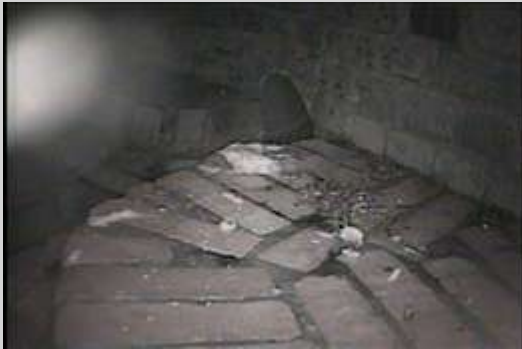
12 O'Clock Outflow

8 in. Circular Gravity Sewer
Pipe Out @ 12 O'Clock

Pipe Height: **8.4** (in.) Rod and Bar (Angled)
Pipe Material: **Clay** ☐ Pipe Lined
Invert Depth: **9.61** (ft.) Flow Characteristics: **Slow**
Deposits: ☒ None ☐ Mud ☐ Sludge ☐ Debris ☐ Grease
Silt Depth: (in.) Deposits Extent:
Infiltration: **None** Pipe Seal Cond: **Sound**

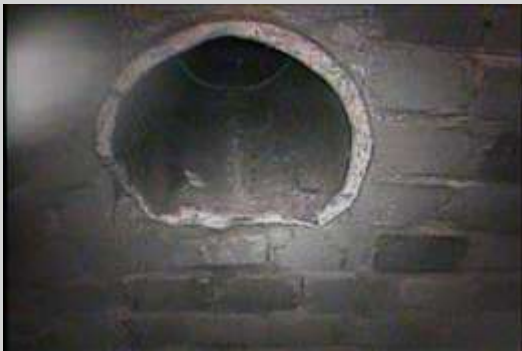
6 O'Clock Inflow

8 in. Circular Gravity Sewer
Pipe In @ 6 O'Clock

Pipe Height: **8.4** (in.) Rod and Bar (Angled)
Pipe Material: **Clay** ☐ Pipe Lined
Invert Depth: **5.40** (ft.) Flow Characteristics: **Fast**
Deposits: ☒ None ☐ Mud ☐ Sludge ☐ Debris ☐ Grease
Silt Depth: (in.) Deposits Extent:
Infiltration: **None** Pipe Seal Cond: **Broken**

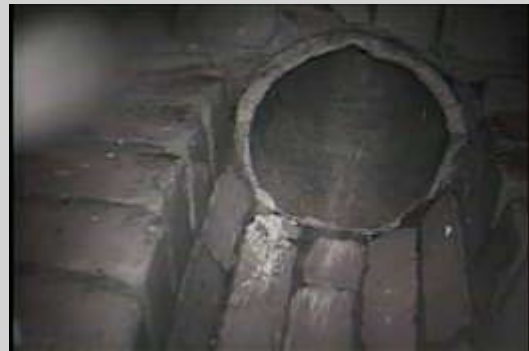
Drop In @ 6 O'Clock

Drop: **Outside** Rod and Bar
Angled: **Yes** Reading: **8.13** (ft.)
Inv Depth: **9.13** (ft.)
Drop Condition: **Open**

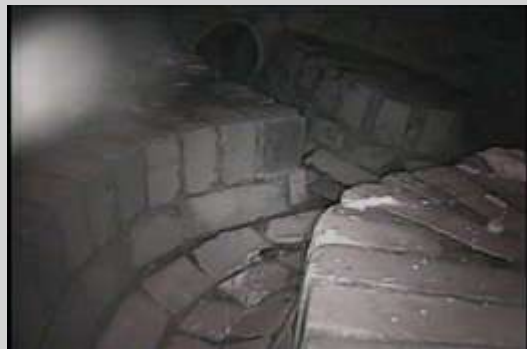
9 O'Clock Inflow

8 in. Circular Gravity Sewer
Pipe In @ 9 O'Clock

Pipe Height: **7.2** (in.) Rod and Bar (Angled)

Pipe Seal Cond: **Sound**
